# All-Ceramic Restorative System for Esthetic Implant-Supported Crowns: In Vitro Evaluations and Clinical Case Report

**Abstract:** *Patient demands for improved esthetics have prompted the development of all-ceramic restorative systems for dental implants, but material strength and restorative costs have presented clinical challenges. Therefore, a new restorative system with tooth-shaped ceramic copings for the anterior and premolar jaw regions has been introduced to address these problems. Fatigue and 17° compression tests were conducted in vitro to assess the mechanical strength of the 6 tooth-shaped copings and several luting agents of the system. A case report on the clinical use of the components is presented. All 6 tooth-shaped copings significantly exceeded the range of forces associated with restoration in the anterior jaw. Crown-endurance limits for fatigue and 17° compression were 70% higher and 46% higher, respectively, than the established minimum-fatigue-endurance limits in those categories. In clinical evaluation, the ceramic restorative system performed well and produced excellent results; it has potential for implant restorations in the anterior and premolar regio

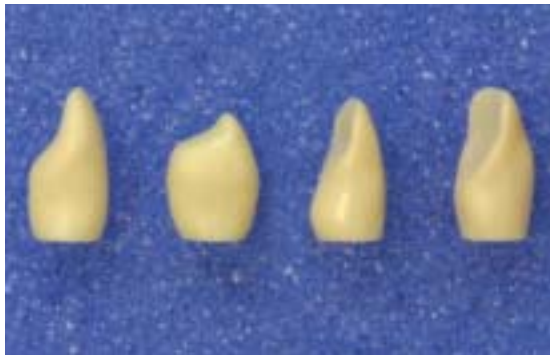
**Figure 1**—Tooth-shaped ceramic copings serve as the underlining of the ceramic crown.

The ceramic restorative system (PureForm™,<sup>a</sup>) consists of 6 ceramic (70% alumina, 30% zirconia) copings shaped like prepared natural teeth and titanium-core abutments that provide a machined interface with the implants for the finished crowns (Table 1; Figures 1 and 2). Porcelain is applied directly to the ceramic cop-

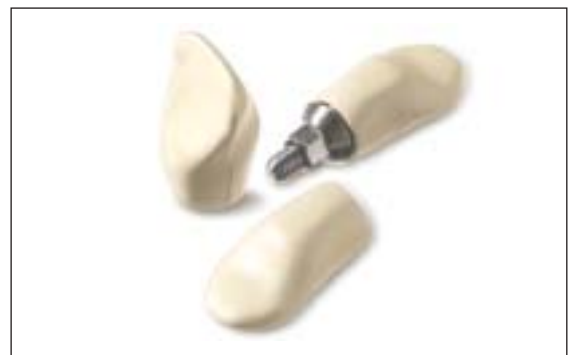
**Figure 2**—The ceramic coping attaches to the metal base component before porcelain application.

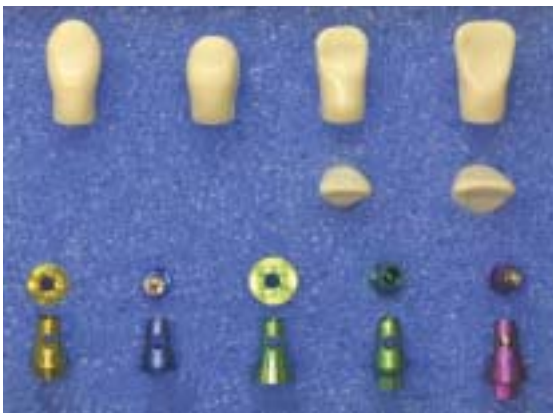
**Figure 3**—Try-in kit. Plastic tooth copings with color-coded base components facilitate selection of the appropriate components.

ing without waxing or casting, and the finished, all-ceramic crown is cemented onto a titanium core, which provides a precision-machined interface with the implant. The system also includes a try-in kit to help guide implant placement (Figure 3).

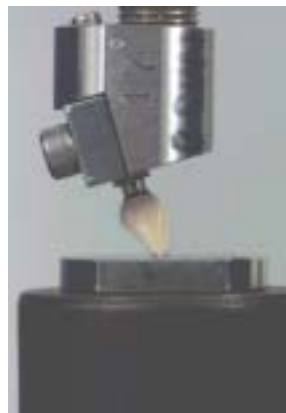
**Figure 4**—Setup for compression and fatigue is accomplished.

In vitro fatigue and 17° compression tests were conducted to assess the mechanical strength of individual restorations using each of the 6 ceramic-coping designs of the system (Figure 4). Two independent laboratories (Centre City Dental Lab, Escondido, CA; Rocco's Dental Studio, Escondido, CA) prepared and restored the test copings according to the manufacturer's specifications. For the evaluation of strength and heat generation in worst-case conditions, diamond grinding wheels<sup>c</sup> were used without irrigation to prepare each coping to a minimum wall thickness of 0.5 mm. Porcelain

For each test sample, a dental implant (Splint<sup>™</sup> Twist<sup>™,a</sup>) was stabilized in a bed of bone cement. A titanium-core abutment was placed directly onto the implant and secured with a retaining screw tightened to a torque of 28.25 Ncm (2.5 in-lbs). The finished porcelain crown was sterilized in an autoclave at 250° for 60 minutes and cemented onto the core abutment with either zinc phosphate or glass-ionomer cement (Table 2). An independent engineering laboratory mounted the completed assembly in MTS equipment (MTS Equipment Corporation,

Eden Prairie, MN) and subjected it to fatigue or 17° compression testing (Engineering Materials Laboratory, Santa Fe Springs, CA). Failure of the retaining screw or implant was defined as any distortion, bending, or breakage of the component, and crown failure was defined as any chipping or cracking of the porcelain or cement failure resulting in the detachment of the crown from the core abutment.

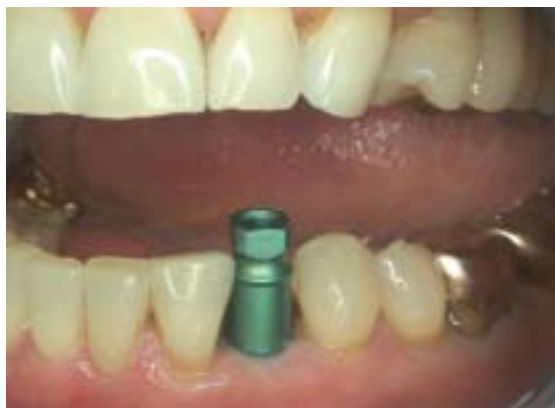
**Figure 5**—The impression post is attached to the implant. Note that the flat surface is oriented toward the buccal for an internal hexagon implant.

At patient recall the healing collar was removed, an impression post was attached to the implant (Figure 5), and a full-arch impression was made. After setting, the impression was removed from the patient's mouth, and the area surrounding the posthole was lubricated with petroleum jelly. The impression post was unthreaded from the implant in the patient's mouth, threaded into an implant analog, and the assembly was inserted into the corresponding impression hole (Figure 6). Soft-tissue replication material (IPS Express<sup>®i</sup>) was injected around the transfer assembly, the impression was poured in dental stone, and the working cast was separated after setting (Figure 7). The healing collar was reattached to the implant, and the patient was dismissed until delivery of the definitive prosthesis.

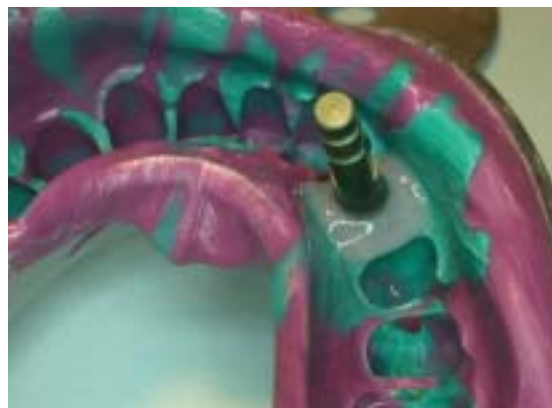
**Figure 6**—Soft-tissue replication material is injected around the assembled impression post and implant analog before pouring the impression in dental stone.

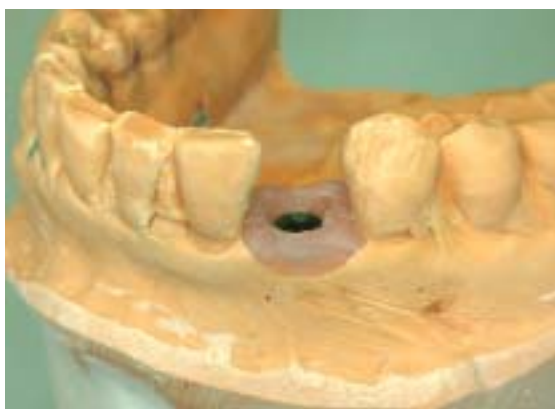
**Figure 7**—Removal of the impression post reveals the internal hexagon interface of the embedded implant analog in the working cast.

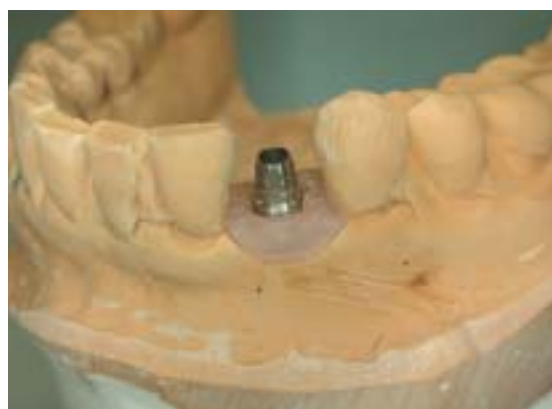
**Figure 8**—The core abutment is attached to the implant analog in the working cast with its retention screw. Note the buccal orientation of the flat side of the abutment.

The impression post was removed from the working cast in the laboratory. A core abutment with a 1.5-mm cuff height was seated on the implant analog in the working cast with the flat side of the abutment oriented buccally and

secured in place using a retaining screw tightened to 30 Ncm of torque to fully engage the friction-fit connection of the component (Figure 8). The cuspid plastic try-on tooth was seated on the core abutment in the working cast (Figure 9) to verify that the equivalent ceramic tooth was the optimum design for the restoration (Figures 10 and 11). Reduction and contouring of the ceramic coping was accomplished with high-speed diamond wheels and external irrigation to prevent excessive heat generation. The prepared ceramic coping was blasted with alumina at 38 psi and steam-cleaned for 45 seconds. Porcelain with a coefficient of thermal expansion that ranged from  $6.9 \times 10^{-6}$  to  $8.1 \times 10^{-6}$  (VITADUR® ALPHA<sup>1</sup>) was applied to the ceramic coping and finished according to the manufacturer's recommendations and conventional laboratory procedures.

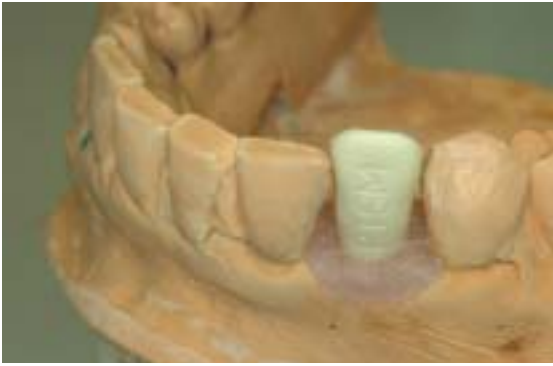
**Figure 9**—The plastic try-in coping is placed on the core abutment to verify its emergence profile relative to the adjacent dentition.

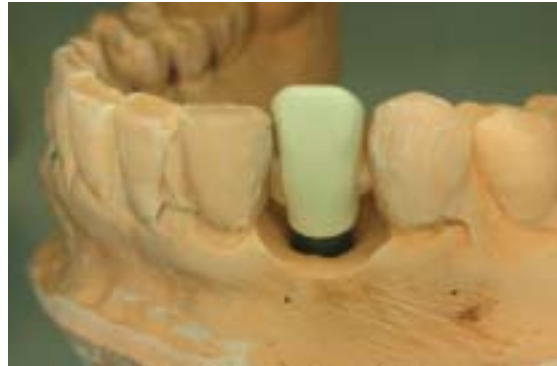
**Figure 10**—The premolar ceramic coping is seated on the working cast.

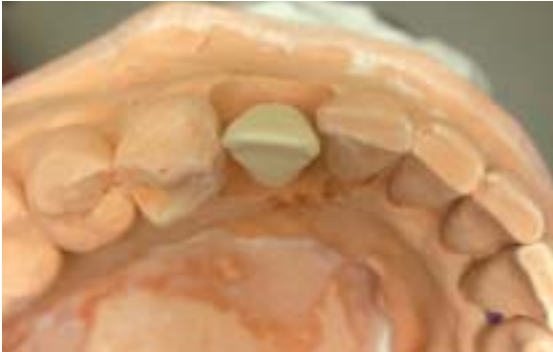
**Figure 11**—Occlusal view of the premolar ceramic coping shows excellent contours for fabrication of the ceramic crown.

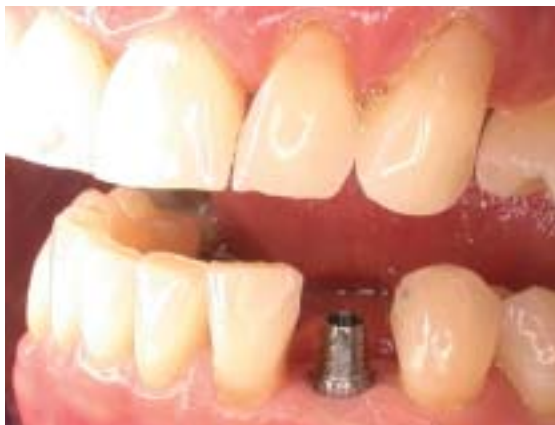
**Figure 12**—The core abutment is attached to the implant. Note the buccal orientation of the flat side of the component.

Ncm of applied torque (Figure 12). Full seating of the core abutment was verified radiographically. The access hole of the core abutment was occluded with a cotton pellet (Figure 13) and composite material to prevent the ingress of crown cement and facilitate future retrieval. The porcelain crown was cemented onto the core abutment with glass-ionomer cement (Ketac™-Cem). Excess cement was removed from the margin area, and the occlusion and bite were adjusted with conventional crown-and-bridge techniques (Figure 14).

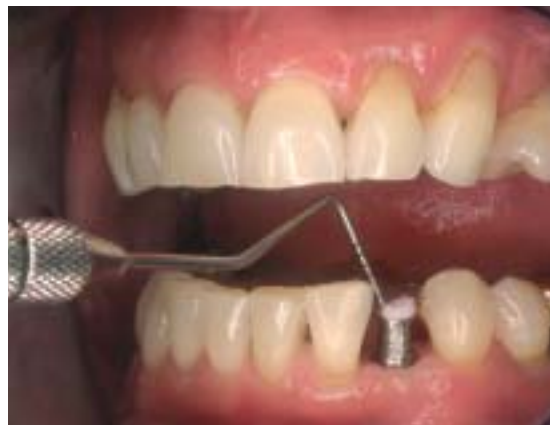
**Figure 13**—The core abutment is occluded with cotton and composite material to prevent the ingress of crown cement.

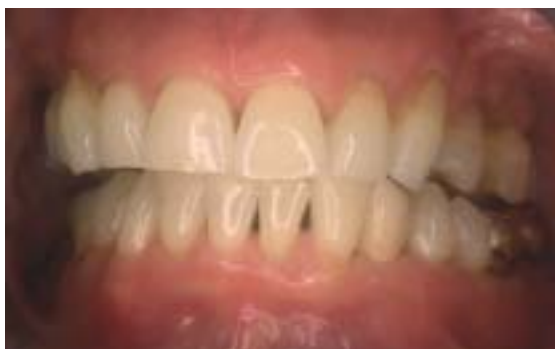
**Figure 14**—The finished crown is cemented onto the core abutment to complete the case.
