# Case Study

## Delayed Replacement of Maxillary Right 1<sup>st</sup> and 2<sup>nd</sup> Premolars with Tapered Screw-Vent and Zimmer® Trabecular Metal™ Dental Implants in Low-Density Bone

### Case#1

Author: Dr. Edgard El Char (USA)

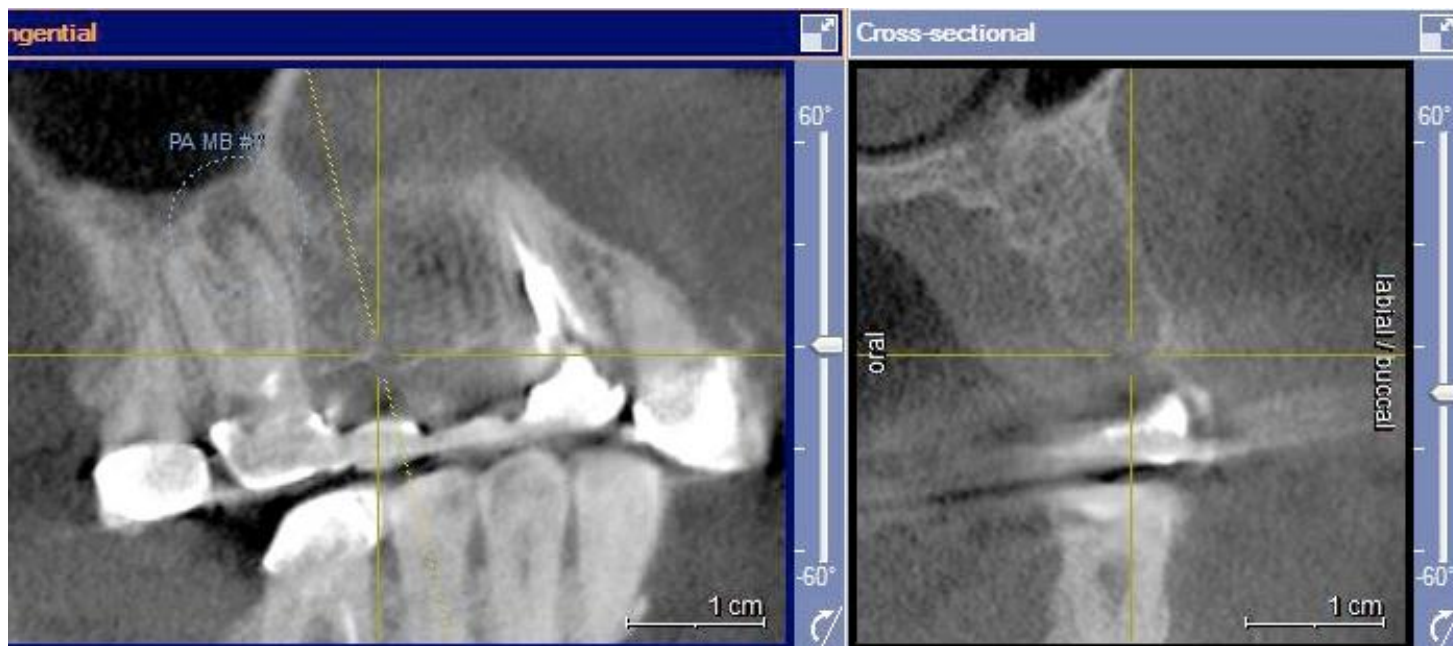
### CAT Scan of Patient

**A 60-year-old partially edentulous male with missing maxillary right 1<sup>st</sup> and 2<sup>nd</sup> premolars presented with a failed bridge in Type III to Type IV bone.**

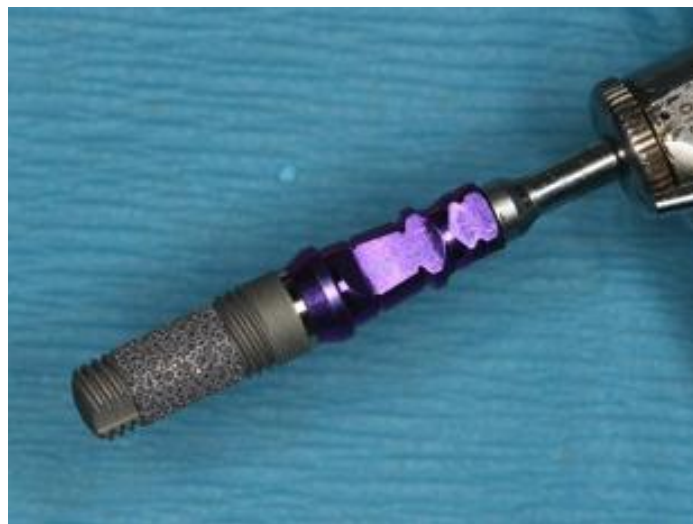
**During preparation of two implant osteotomies, Type III to Type IV bone was observed in the 2<sup>nd</sup> premolar location, so a *Zimmer® Trabecular Metal™* Dental Implant, 4.7 mm x 11 mm, was delivered and placed in the site.**
