Case Study

Sinus Graft Using the Crestal Approach and Replacement of a Maxillary Left 1st Molar with a Zimmer[®] Trabecular Metal[™] Dental Implant

Case#2

Author: Dr. Edgard El Chaar (USA)

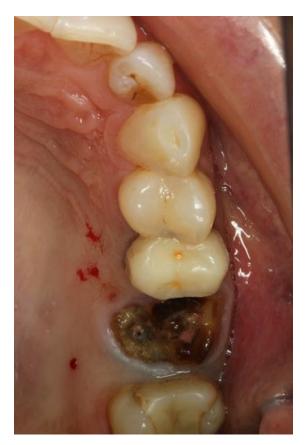
Occlusal view of a fractured and decayed maxillary left 1st molar

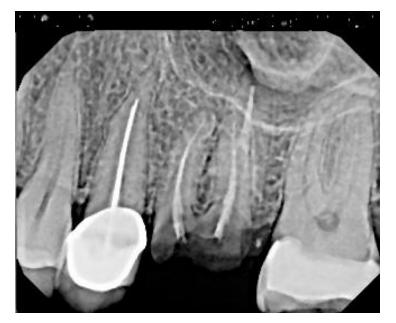
Periapical radiograph shows residual root fragments from the fractured maxillary left 1st molar area.

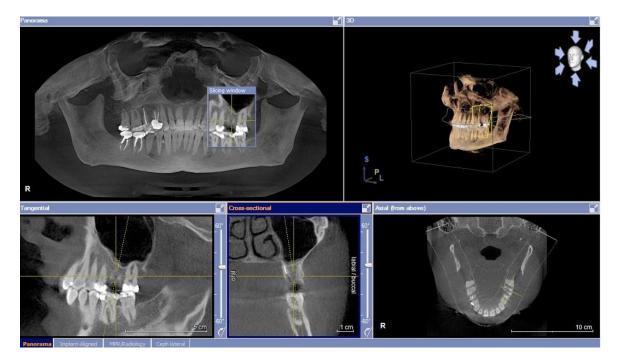
CAT Scan of patient with the following views, Panoramic, 3-D, Tangential, Cross section and Occlusial.

Computed Tomography of the treatment site shows panoramic, three-dimensional, tangential, cross-sectional and occlusal views.

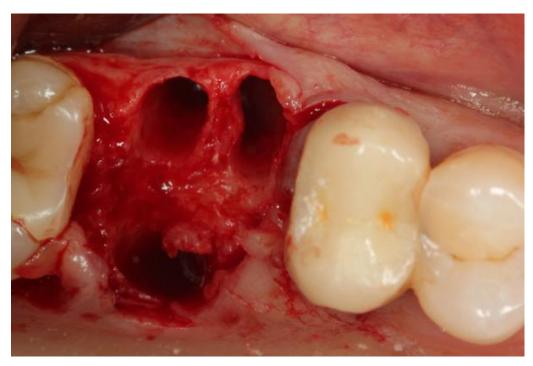
Preparation of the extraction socket for placement of the dental implant. Root fragments were carefully removed using an atraumatic technique to preserve the surrounding bony architecture.

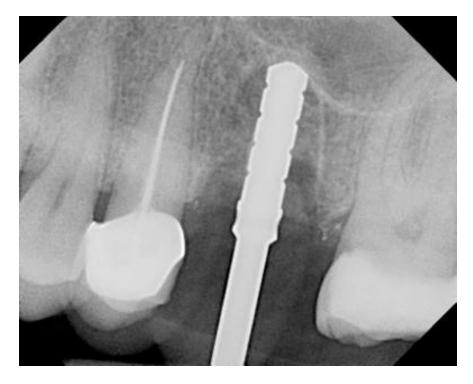
Periapical radiograph of the paralleling post placed in the osteotomy to determine if an angle correction is needed.

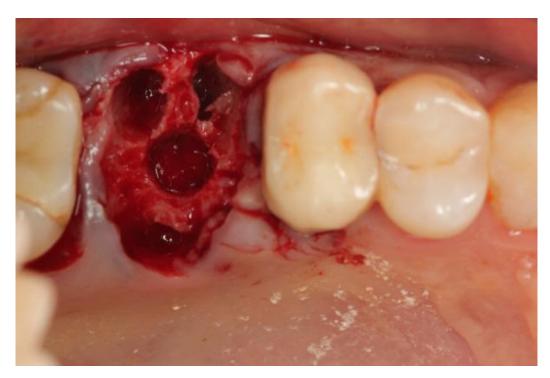
After preparation of the implant site, a 2mm sinus elevation is performed with osteotomies and grafted with *Puros* Cancellous Particulate Allograft. The completed osteotomy is ready for implant placement.

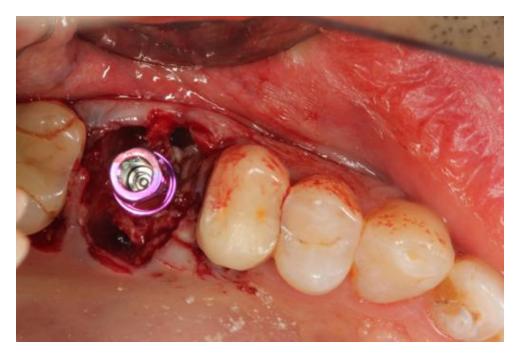
A Zimmer[®] Trabecular Metal[™] Dental Implant, 4.7 mm x 10 mm, was placed in the extraction site. Its fixture mount will be replaced by a healing collar for a nonsubmerged surgical protocol.

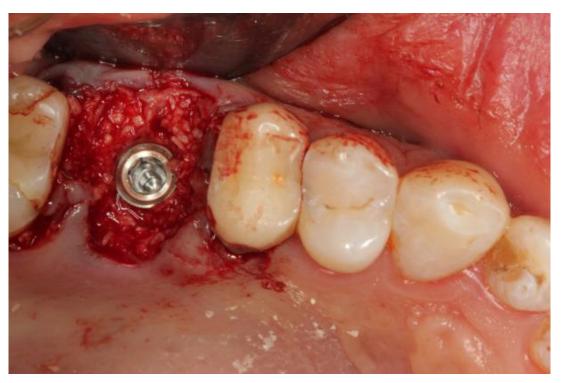
Puros Cancellous Particulate Allograft material is hydrated, then used to fill the remaining sockets and any additional voids around the implant. After filling, each sockets is occluded with *CollaPlug*[®] *Absorbable Collage Wound Dressing*.

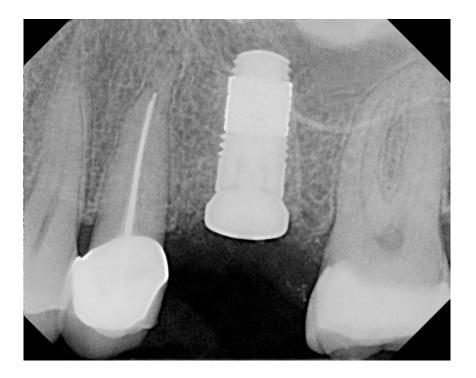
Periapical radiograph shows the *Zimmer® Trabecular Metal™* Dental Implant and healing collar in place.

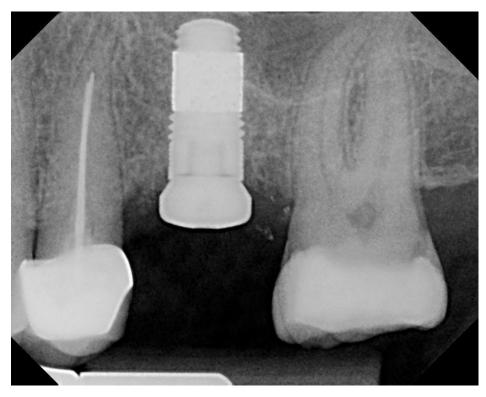
Periapical radiograph taken at two months after the *Zimmer*[®] *Trabecular Metal*[™] Dental Implant placement shows a significant degree of bone densification around the implant.

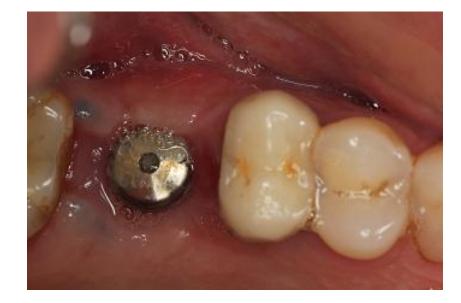
Occlusal view at two months after the Zimmer[®] Trabecular Metal[™] Dental Implant placement

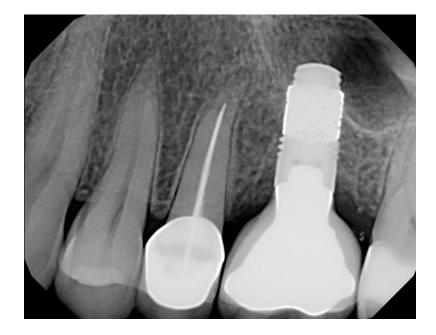
Final restoration at four months post implant placement.

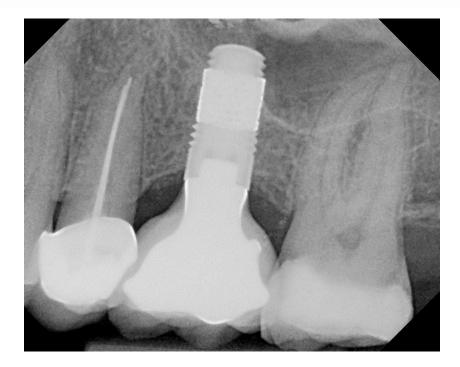
Periapical radiograph of *Trabecular Metal™ Dental* Implant with final restoration. One year postplacement with over six months of functional loading.
